C-130 WELDBONDED FUSELAGE PANEL FLIGHT EVALUATION PROGRAM

J. A. KIZER

DECEMBER 1977

FINAL REPORT OCTOBER 1974-DECEMBER 1977

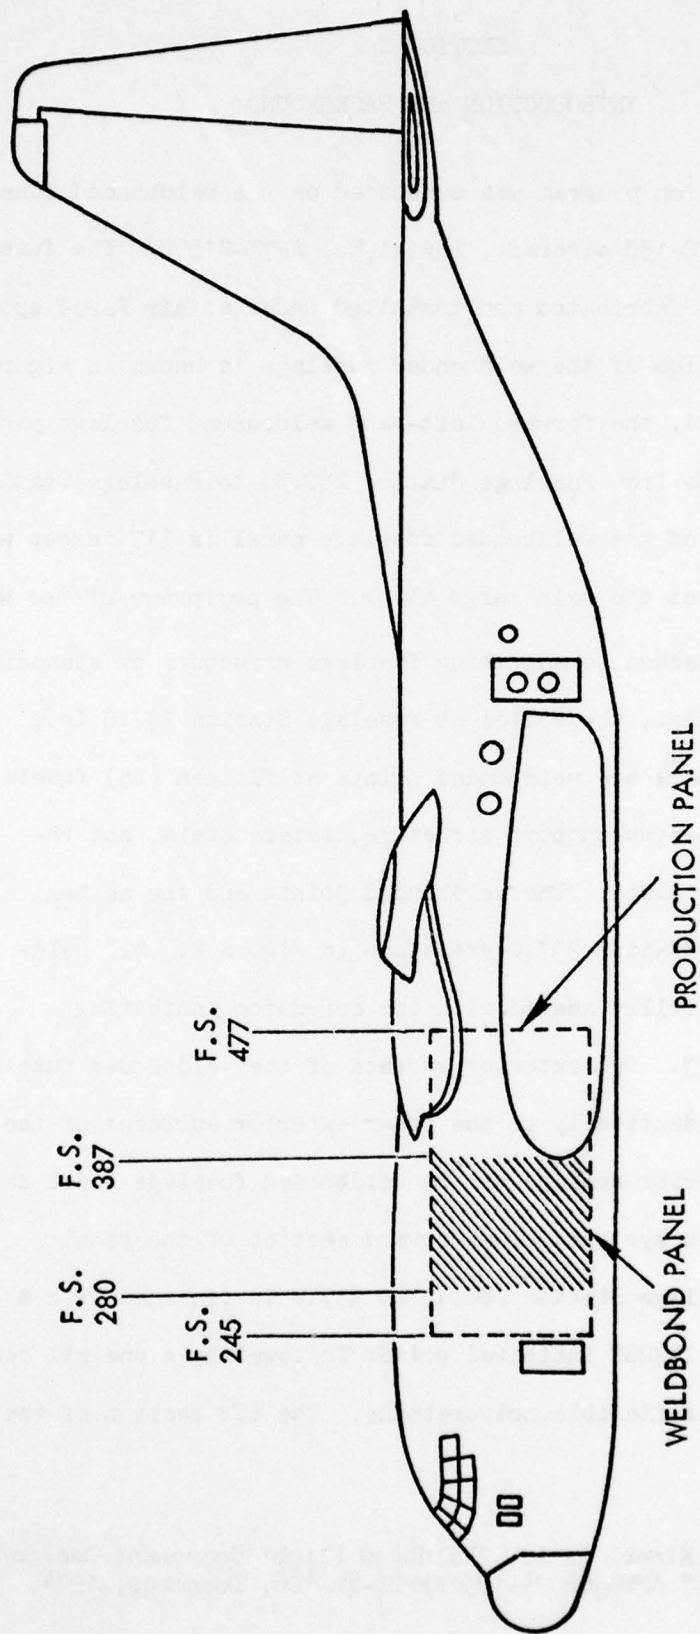
Figure 1 - Weldbonded Panel Installed in Forward Left
Side of C-130 Fuselage

This flight evaluation program was conducted on the weldbonded fuselage panel installed in C-130 aircraft, Serial No. AF73-01592. The fuselage panel was designed, fabricated and installed under an Air Force sponsored program¹. The location of the weldbonded fuselage is shown in Figure 1. As shown in Figure 1, the forward left-hand weldbonded fuselage panel, Dwg. No. 3307701, extends from Fuselage Station 280.33 to Fuselage Station 337.0. The height of the weldbonded fuselage panel is 117 inches with the upper end attached at the main cargo floor. The periphery of the weldbonded panel is attached to adjoining fuselage structure by standard riveted splices. Also, the splice at Fuselage Station 337.0 is a riveted splice. There are weldbonded joints at fifteen (15) fuselage stations, cargo tie-down support structure, intercostals, and reinforcement doubler plate. The weldbonded joints and the mechanical splice at Fuselage Station 337.0 are shown in Figure 2. All weldbonded joints were fillet sealed with the corrosion inhibiting sealant, MIL-S-81733. The exterior surface of the weldbonded fuselage panel is finished identically to the other exterior surfaces of the aircraft. The interior surface of the weldbonded fuselage panel has two different finish systems. The forward section of the panel extending from Fuselage Station 280.33 to 337.0 is finished with a one mil coat of PR-1432GP inhibited primer followed by a one mil coat of MIL-C-83019 clear flexible polyurethane. The aft section of the

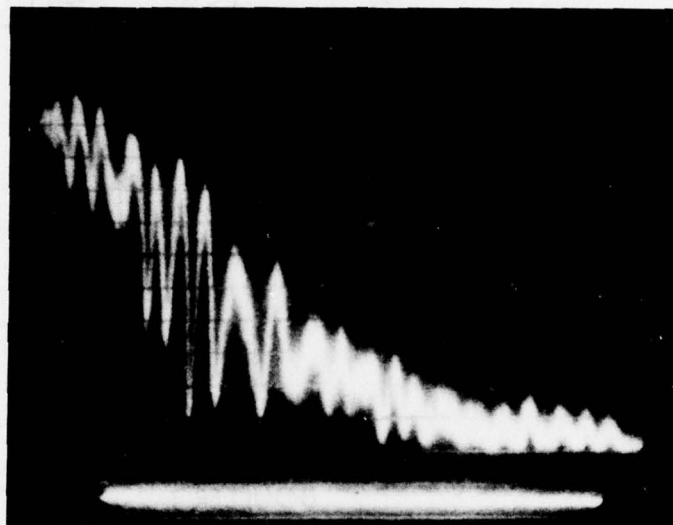
Figure 5 - CRT Signal of a Quality Bondline

- (1) Apply couplant on the designated Area 2 of the standard.
- (2) Place the transducer on a known good quality section of Area 2.
- (3) Adjust the Reflectoscope sweep to obtain a signal occupying approximately 50 percent of the cathode ray tube (CRT) screen. The signal of a quality bondline is as shown on Figure 5.
- (4) Place the transducer over known nearside and farside disbands in the appropriate zones of Area 2 of the standard.
- (5) Adjust the sweep delay/length controls of the Reflectoscope to move all signals off the CRT screen. A representative signal of both types of disbands is shown on Figure 6.
